## Tube support plate clogging up of French PWR steam generators

*Herve BODINEAU & Thierry SOLLIER*

IRSN - Reactor Safety Division

**Abstract:** Between 2004 and 2006, three primary-to-secondary leaks occurred at the Cruas NPP: unit 1 in February 2004 and unit 4 in November 2005 and February 2006. The three leaks were all the result of a circumferential crack in the tube at the location where the tube passes through the uppermost tube support plate (TSP #8).

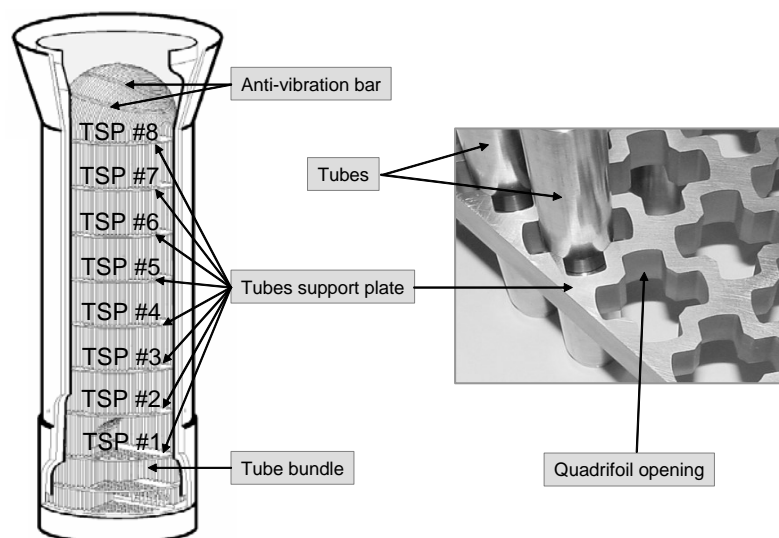
The results of in situ examination initiated by the Cruas NPP operator showed that the flow holes of the uppermost Tube Support Plates (TSPs) were partially or completely blocked by corrosion products. This phenomenon is referred to in this paper as TSP “clogging-up” and it was considered potentially generic for EDF NPP fleet. For the Cruas leakages, it was established that the association of TSP clogging-up and the specificity of the Cruas steam generator (central area in the tube bundle where no tubes are installed) were responsible for a significant increase in the velocity of the secondary fluid in the tube bundle central area. The high velocity of the fluid in this region increases the risk of fluidelastic instability for the tubes. Based on this preliminary analysis, EDF has implemented preventive measures (stabilizing and plugging of tubes in the central area of the tube bundle deemed sensitive to high cycle fatigue risk).

Pic. # 1: Location of the TSP and presentation of quadrifoil openings

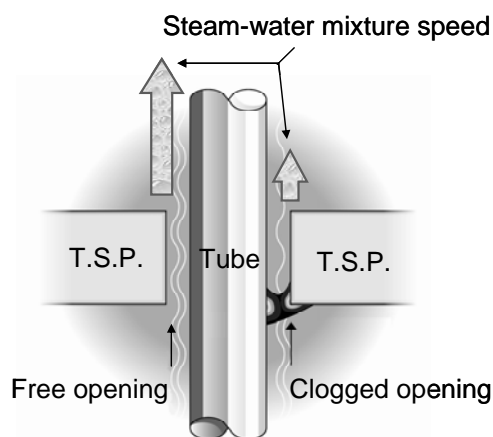
The phenomenon of cracking due to high cycle fatigue of U-bend tubes not supported by an Anti-Vibration Bar (AVB) was highlighted as early as 1987 (tube rupture in the NORTH ANNA 1 plant) and 1991 (MIHAMA). The tubes which leaked at Cruas were all located in raw 8 and were not supported by AVB by design. They were not considered sensitive to high cycle fatigue. A new fact caused the leakages observed on the Cruas units: the heavy build-up of deposits on the secondary side of the steam generator which changed the flow conditions in the center of the tube bundle. The deposits reduced or blocked water/steam flow through the quadrifoil-shaped holes in TSPs, forcing more water and steam into the center of the tube bundle, which caused the excessive vibration of the tubes near the center of the tube bundle. This excessive vibration due to fluid-elastic instability resulted in fatigue cracking of the tube.

Pic. # 3: Representation of the water-steam flow through the quadrifoil holes

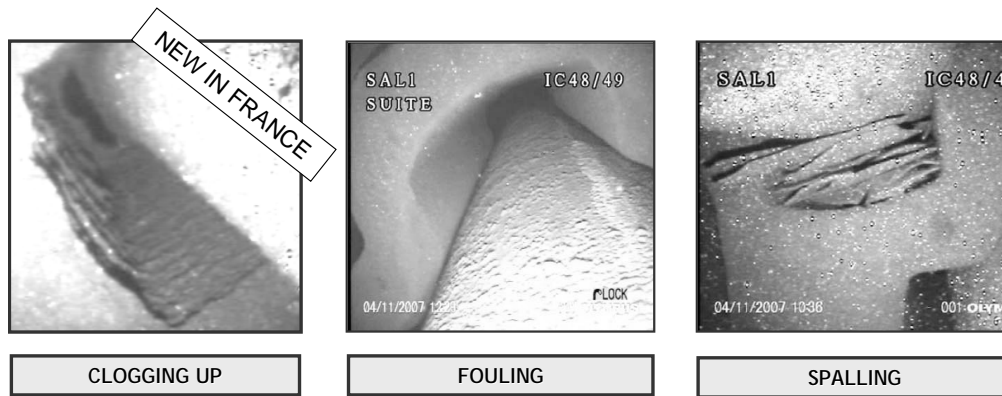
Deposits had already been observed in steam generators on numerous occasions both in France and abroad, for example deposits of metal oxides corresponding to corrosion products (sludge) on the tube sheet. Other deposits had been observed on the external surface of the tubes – called fouling – one of the consequences of which is decreased heat exchange performance in the steam generator. In the case described above, the deposits are located in the quadrifoil-shaped holes in TSPs – known as clogging. Foreign reactors have also experienced this type of deposit but maintenance programs implemented in France were not able to detect it.

Pic. # 5: Difference between clogging up, fouling and spalling

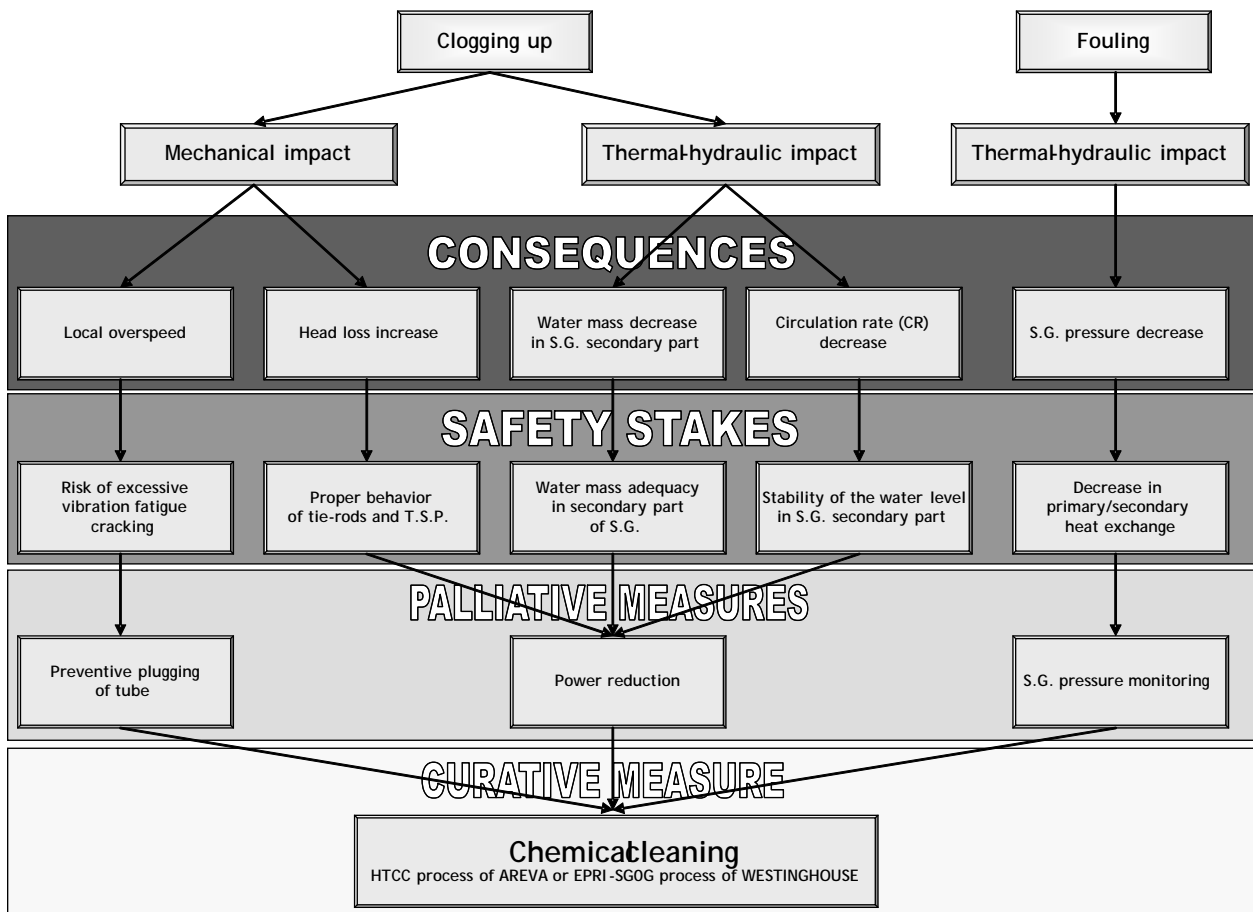
In brief, according to the nature of the anomaly (fouling or clogging up), the consequences on the plant safety are the following:

Pic. # 10: Effects on plant safety with respect to tube fouling and clogging up

On the basis of its safety analysis of the TSP clogging-up, at the end of 2006, IRSN recommended that the ASN (French Nuclear Safety Authority) should ask EDF to clean the tube support plates in the steam generators in Cruas unit 4 within three months.
